Test Report No.: SZXEC25002783002_1 **Date**: Aug 14, 2025 Page 1 of 4

Sample Name: Tansient Voltage Suppressor

Model No.: SOD-323

Halogen

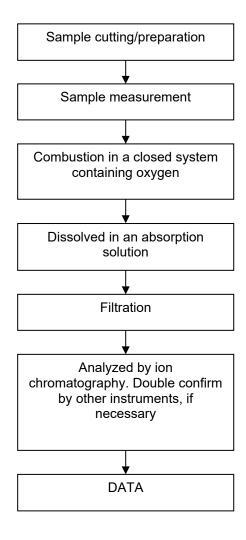
Halogen Testing Flow Chart

Test Method: With reference to EN 14582:2016, analysis was performed by IC.

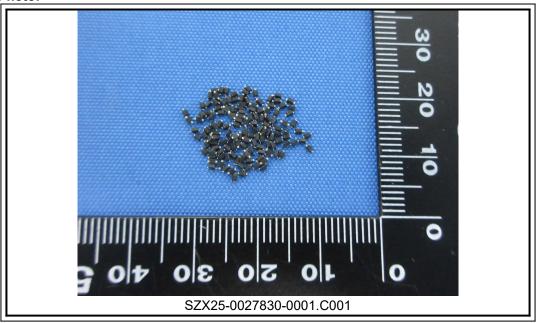
Sample Photo:

SN ID	Sample No.	SGS Sample ID	Description
SN1	A1	SZX25-0027830-0001.C001	"Tansient Voltage Suppressor"
